Physical Processes and Natural Attenuation Alternatives for Remediation of White Phosphorus Contamination, Eagle River Flats, Fort Richardson, Alaska

Daniel E. Lawson, Lewis E. Hunter and Susan R. Bigl

December 1996

CRREL Report 96-13

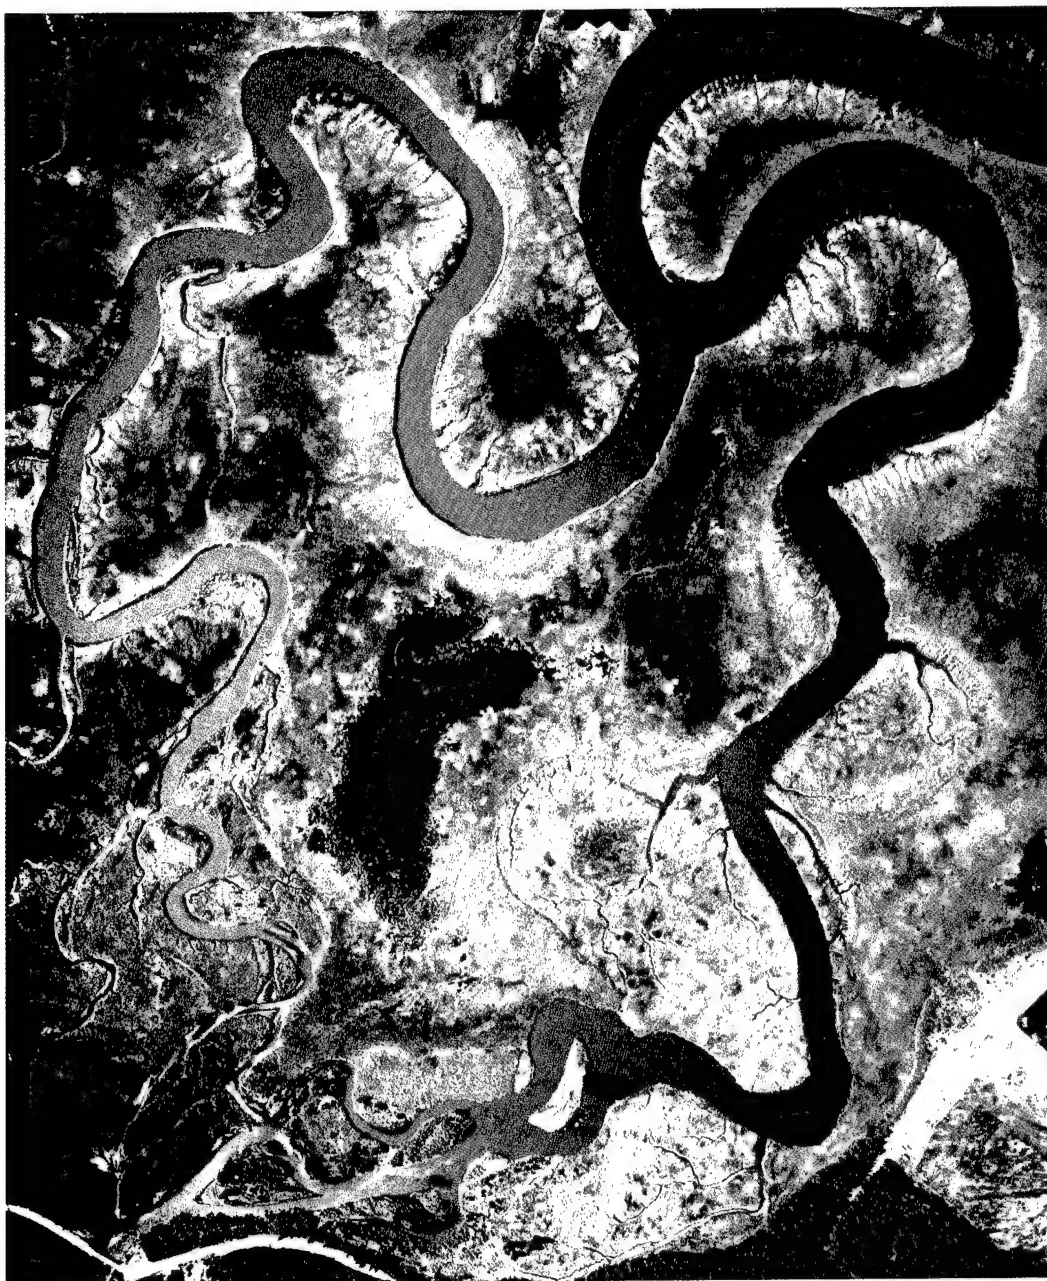
Figure 6. Aerial photograph of Racine Island taken 16 August 1995 showing remnant channel surrounded by overbank deposits.

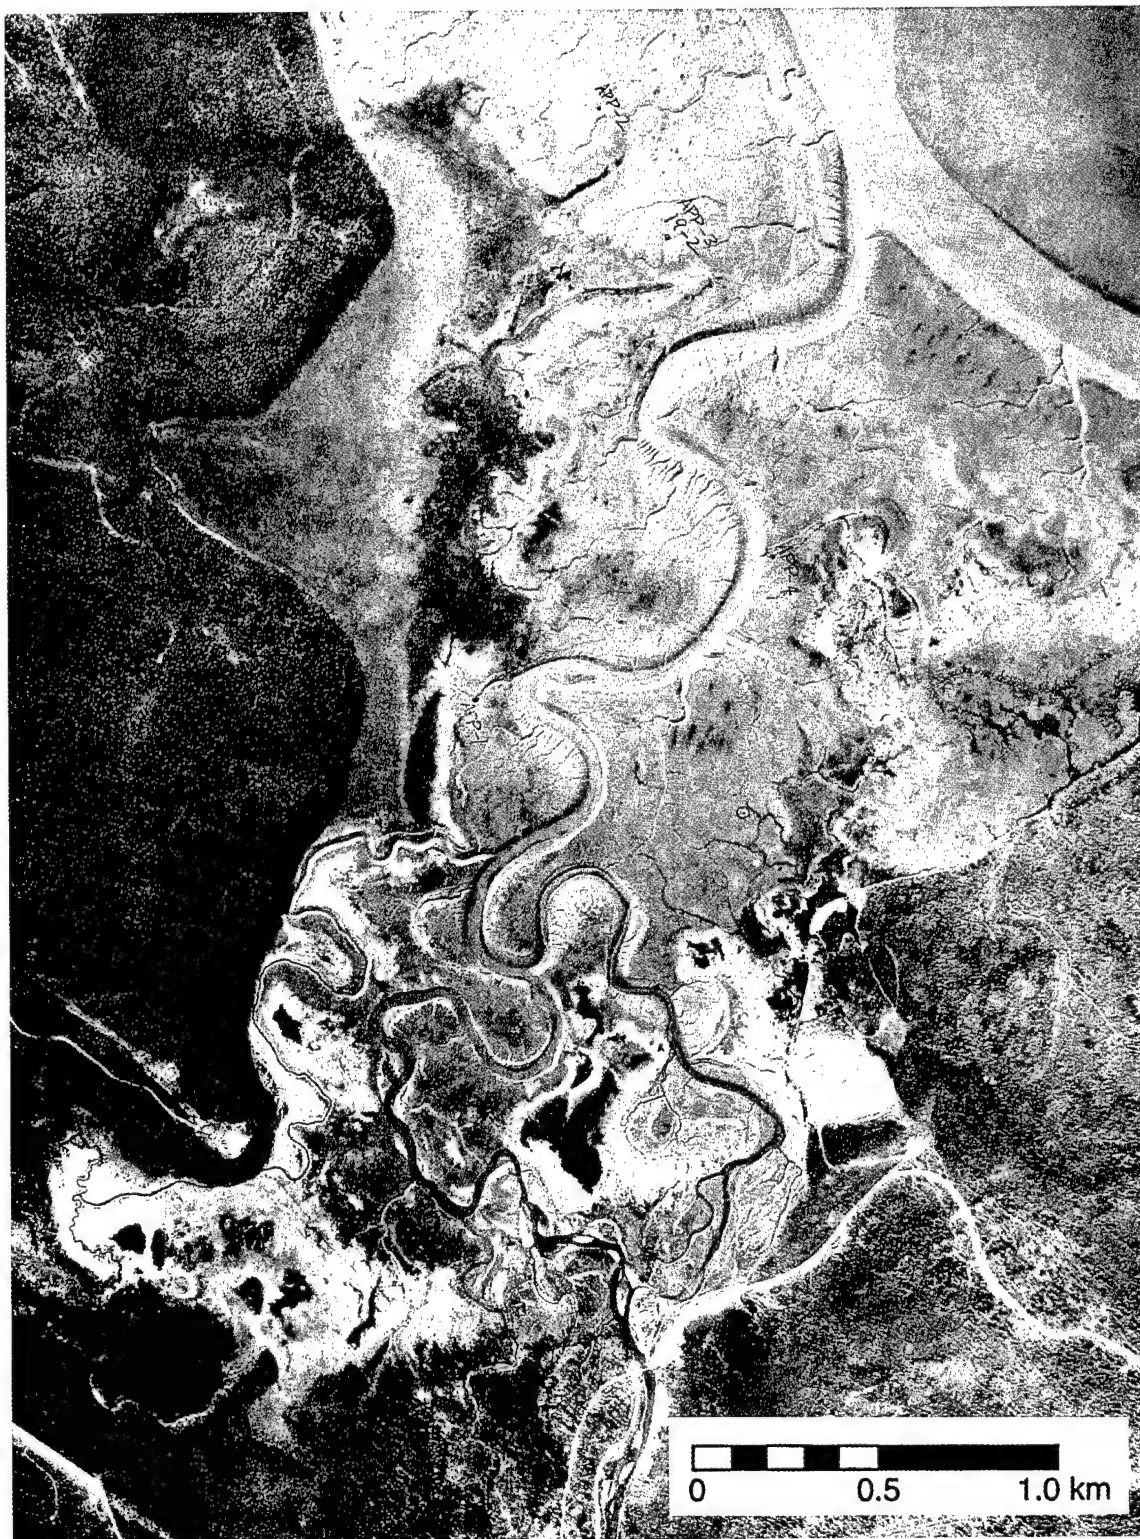
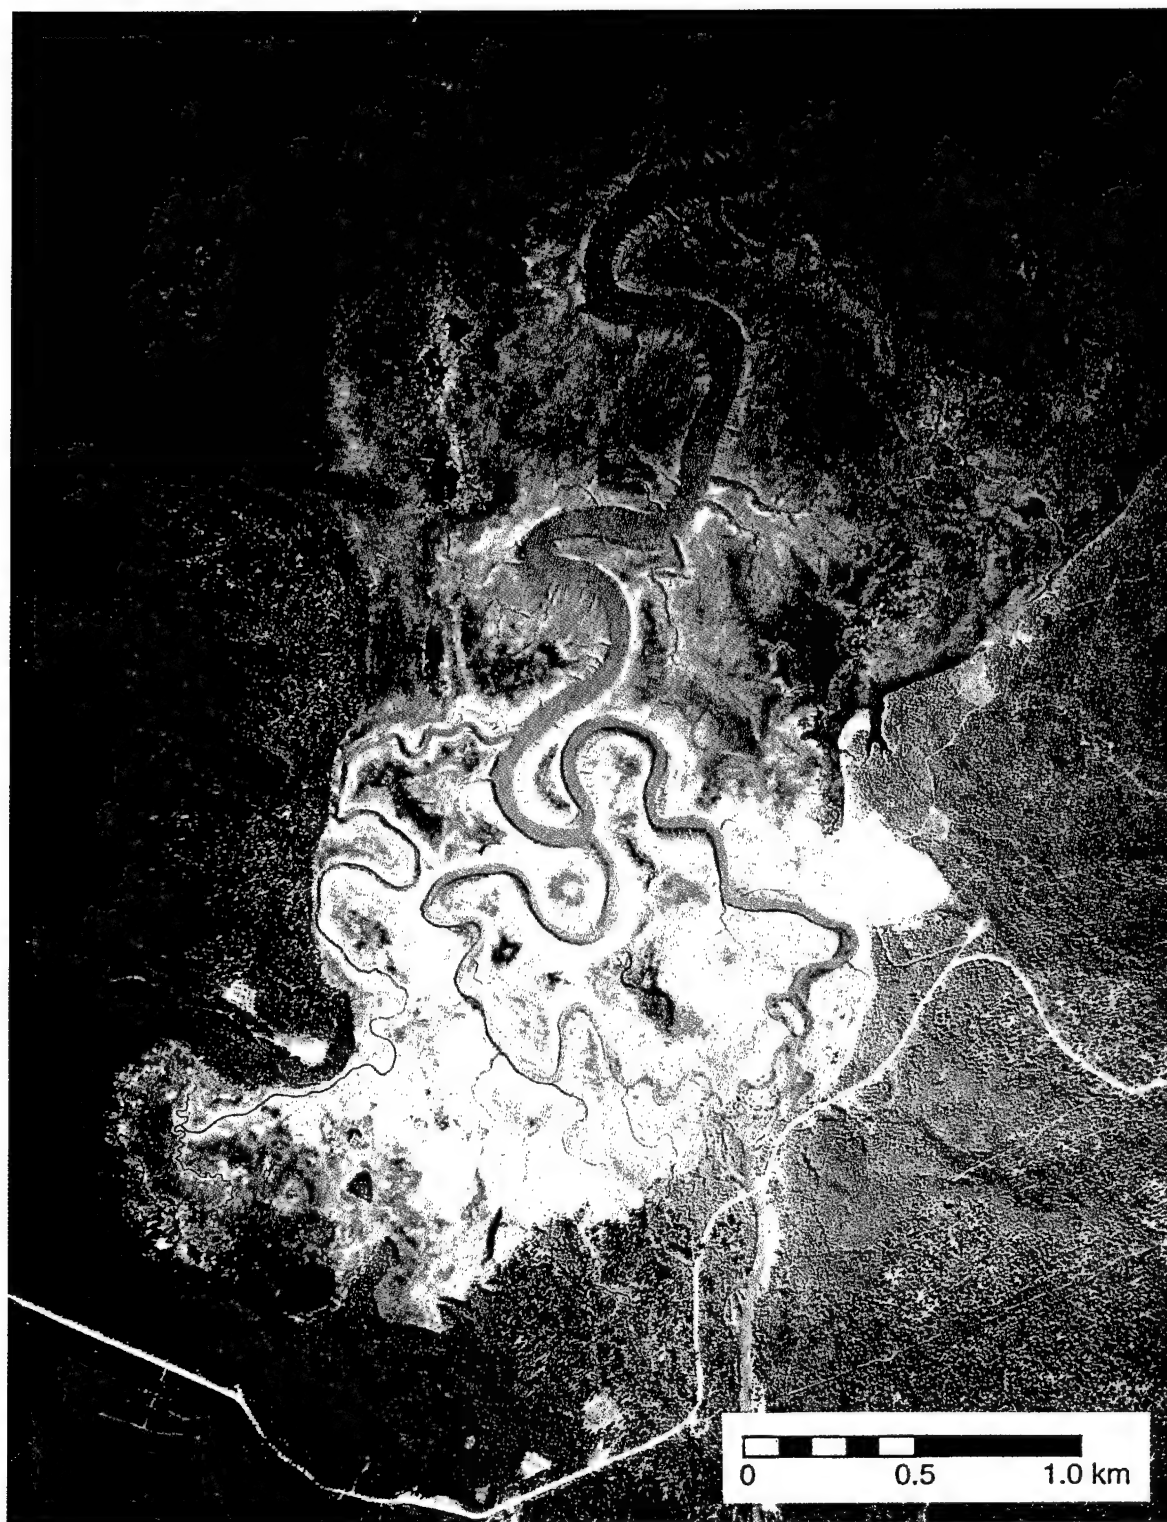
a. 1950.

Figure 7. Aerial photographs of ERF.

b. 1967.

c. 1993.

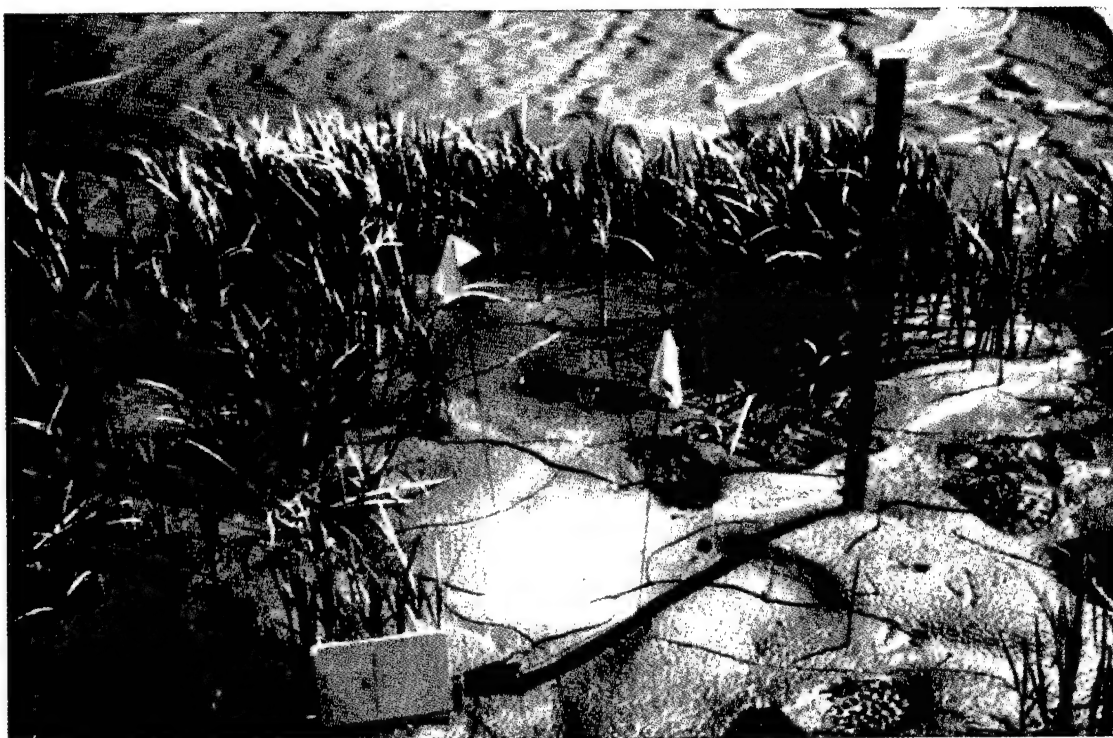
a. Sedimentation stake with plate.

b. Wire flags mark an area of painted ground.

Figure 10. Sedimentation measurement techniques.

Sedimentation on levee and mudflat surfaces was monitored by spraying an area (~30 × 30 cm) on the ground surface with pavement-marking paint and locating the corners of this area with wire survey flags (see also Vince and Snow 1984). Paint was applied at certain sites in June and August 1992, August 1993, and May–June 1994. Net accumulation was measured by cutting and removing a block of sediment with a putty knife or spatula (Fig. 11). The thickness of sediment above the paint layer was then measured to the nearest 0.5 mm. In contrast to the sedimentation stakes that were commonly broken or removed by ice during winter, the wire flags and buried paint horizons enabled us to acquire a continuous record of net sedimentation rates.

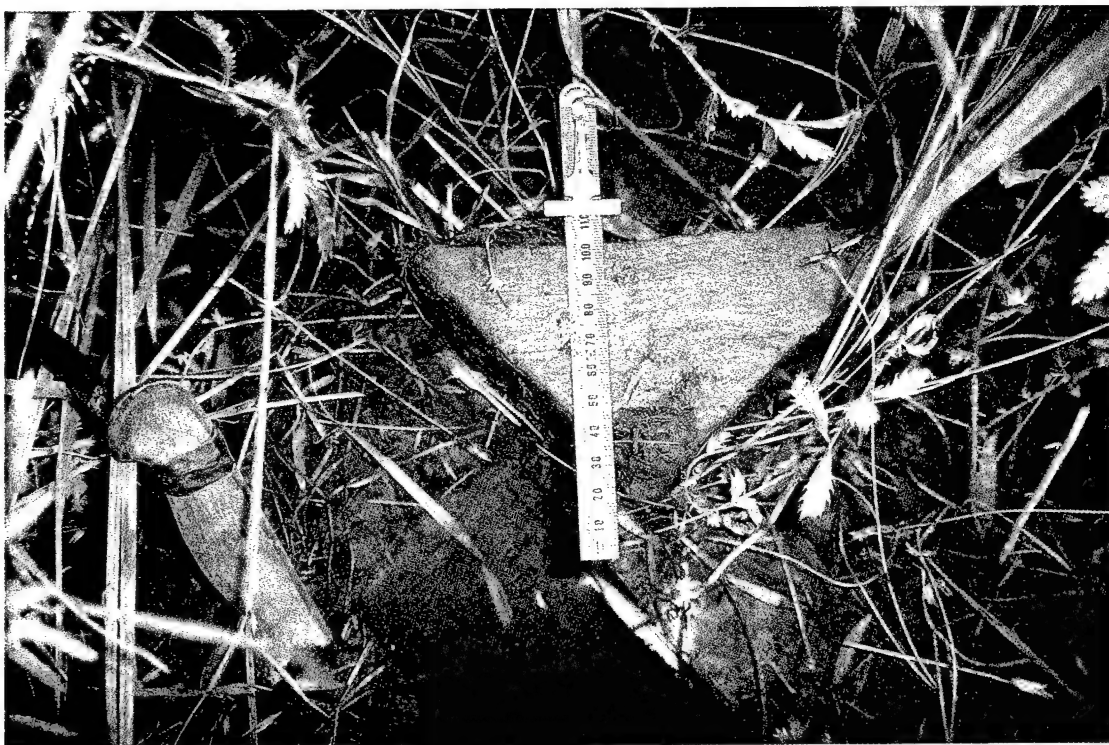
Figure 11. Wedge-shaped sediment block used to measure vertical accretion. Note subhorizontal laminations.

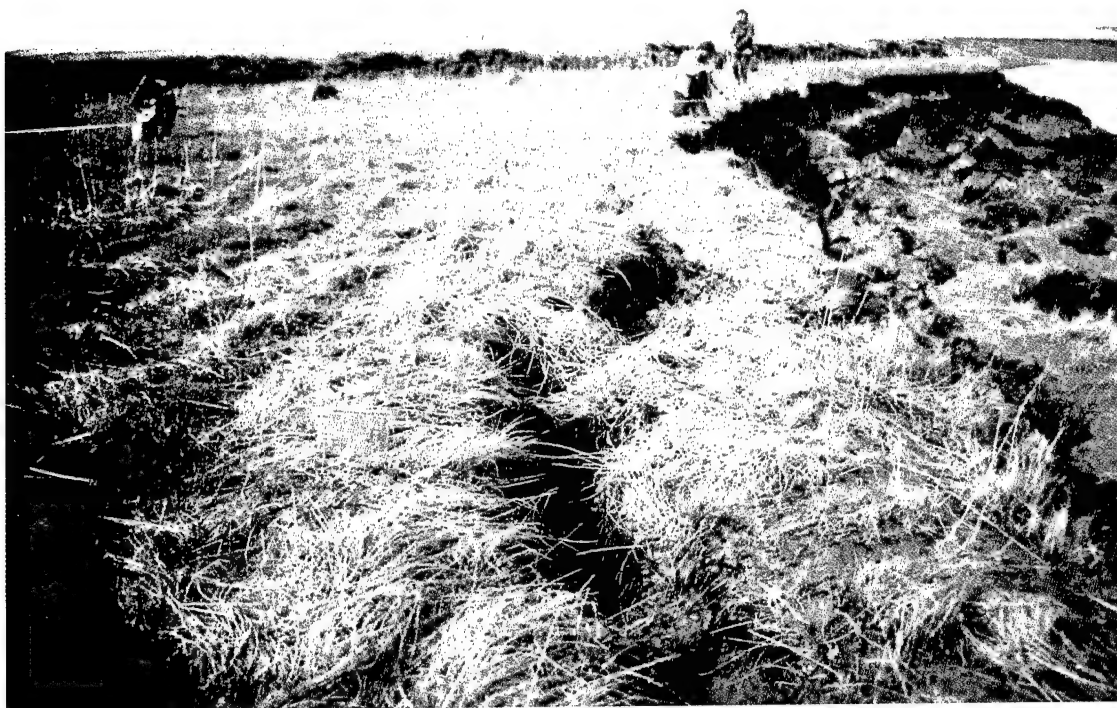
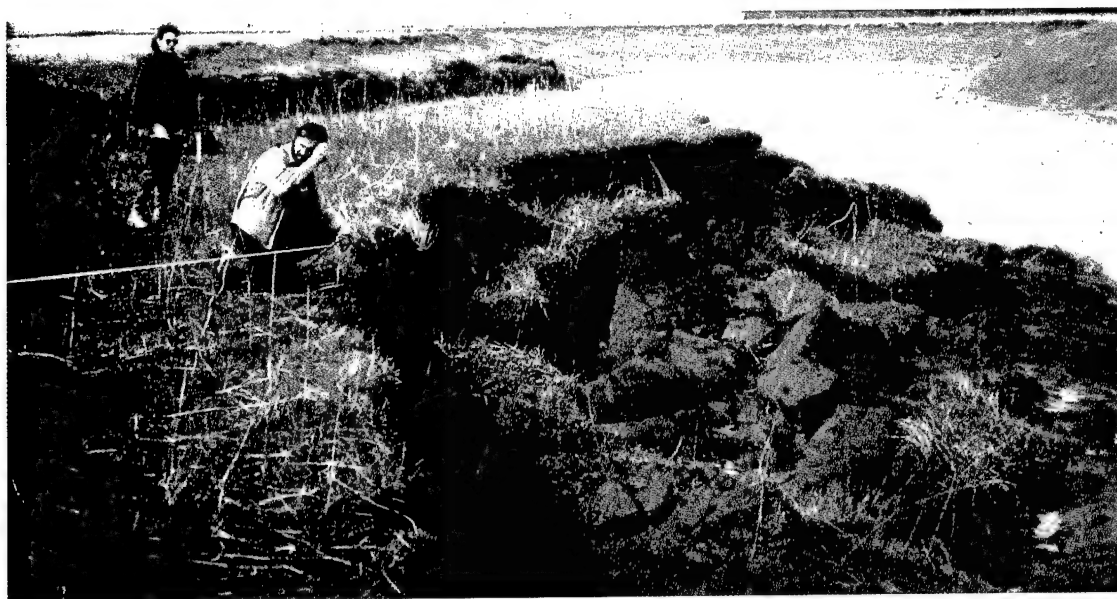
a. North view showing extension crack in foreground.

b. Rotational slump blocks visible to right of scarp.

early stage of collapse (Fig. 24). This extension was particularly evident in May of 1995 following the first tidal flooding cycle (15–17 May 1995) after thawing of the ground began. A shallow snow cover in the winter allowed frost to penetrate deeply. Intermittent flooding and subsequent pond drainage are favorable to ice growth (Fig. 25). The subsequent freezing of interstitial

Figure 23h shows one section of the monitoring network at the River-North site, where slope processes are consuming mudflat sediments and introducing material directly into the Eagle River (Fig. 24). Rapid lateral erosion on the order of 3.2 m was recorded at this site between July and November of 1994, and there was up to 7.4 m of recession by late October 1995. Erosion occurs along large rotational slumps that fail because of river undercutting and removal of sediment supporting the toe of the slope (Fig. 24b). Prior to failure, large extension cracks develop parallel to the scarp, gradually leading to catastrophic failure (Fig. 24a). The location of the crack becomes the new scarp of the riverbank.

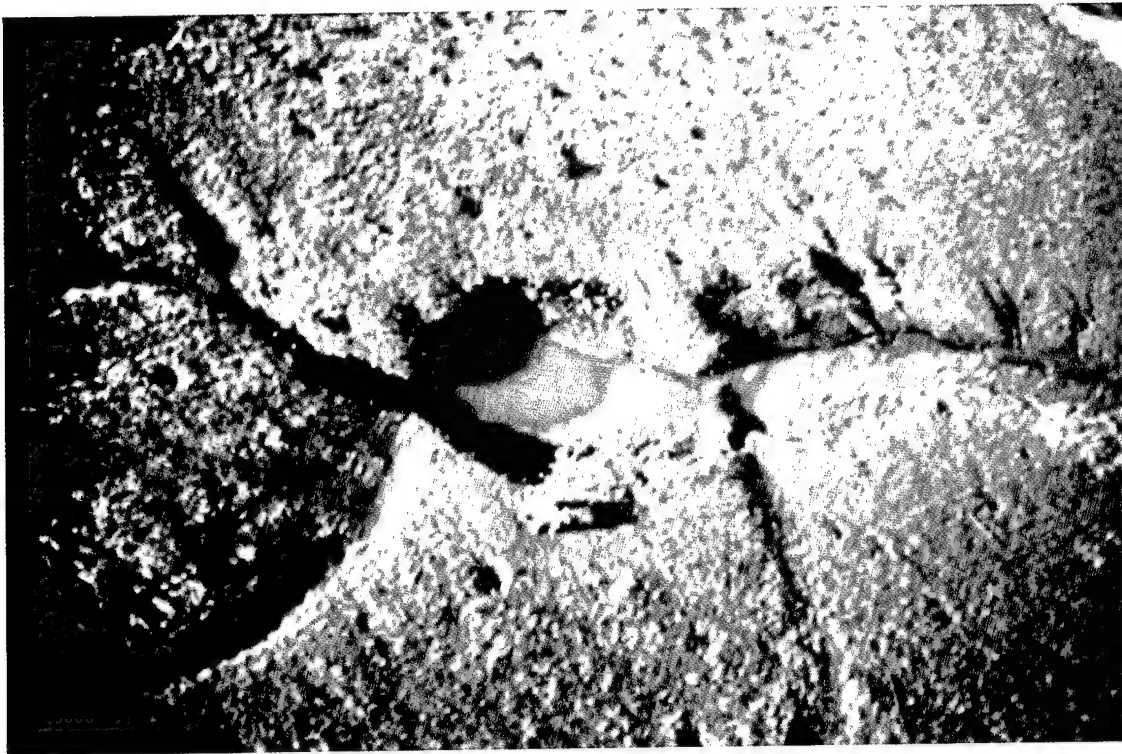
Figure 26. Aerial view of Parachute Gully in October 1995 showing accelerated headward recession that has accompanied capture of flow through craters.

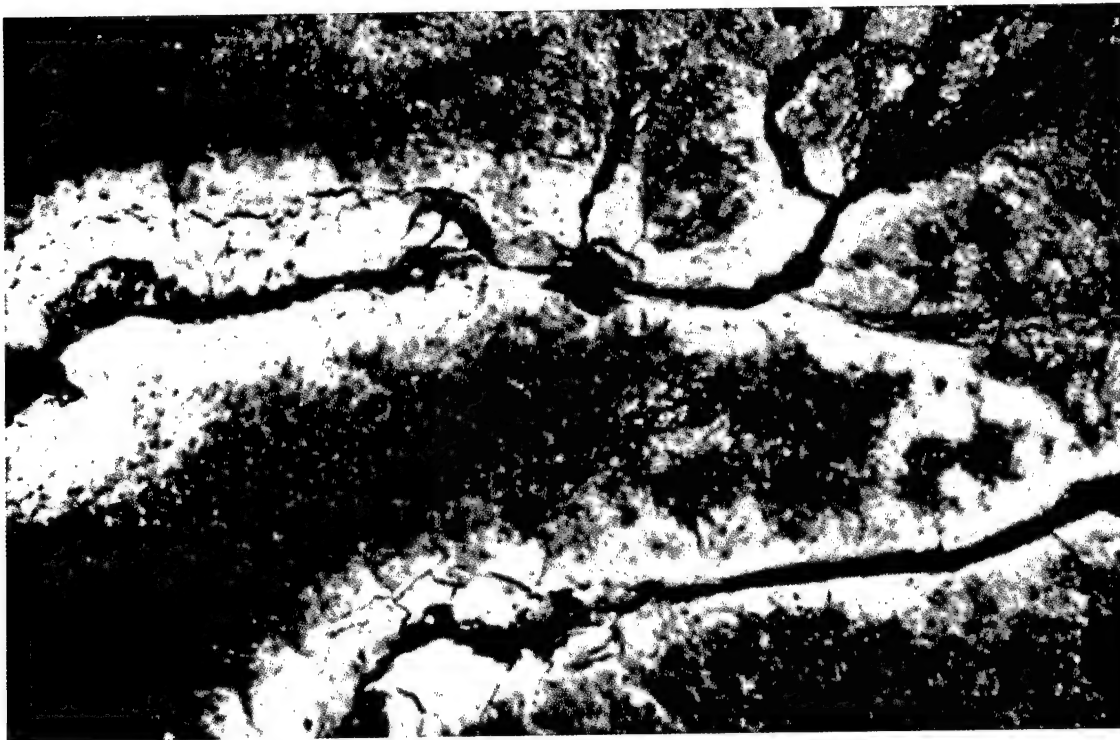
a. Area A.

Figure 27. Aerial view of gullies where recession and ebb flow have been modified by surface craters.

b. B-Gully.

Recession at the B-gully site, monitored since 1992, is the result of lateral erosion. The monitored section lies along the margin of a peninsula

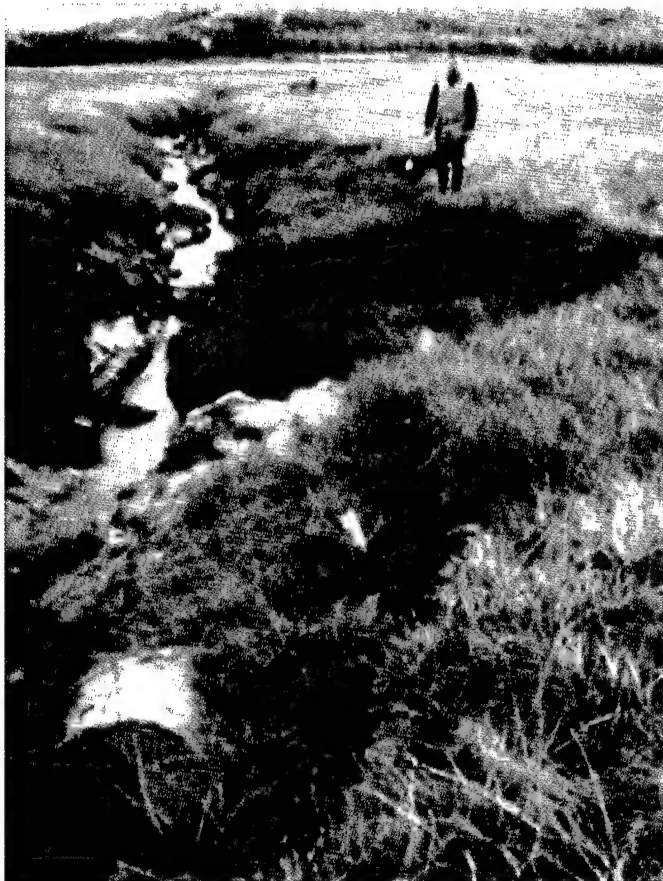
Figure 29. Eastward view of eroding cusped embayments at B-Gully.

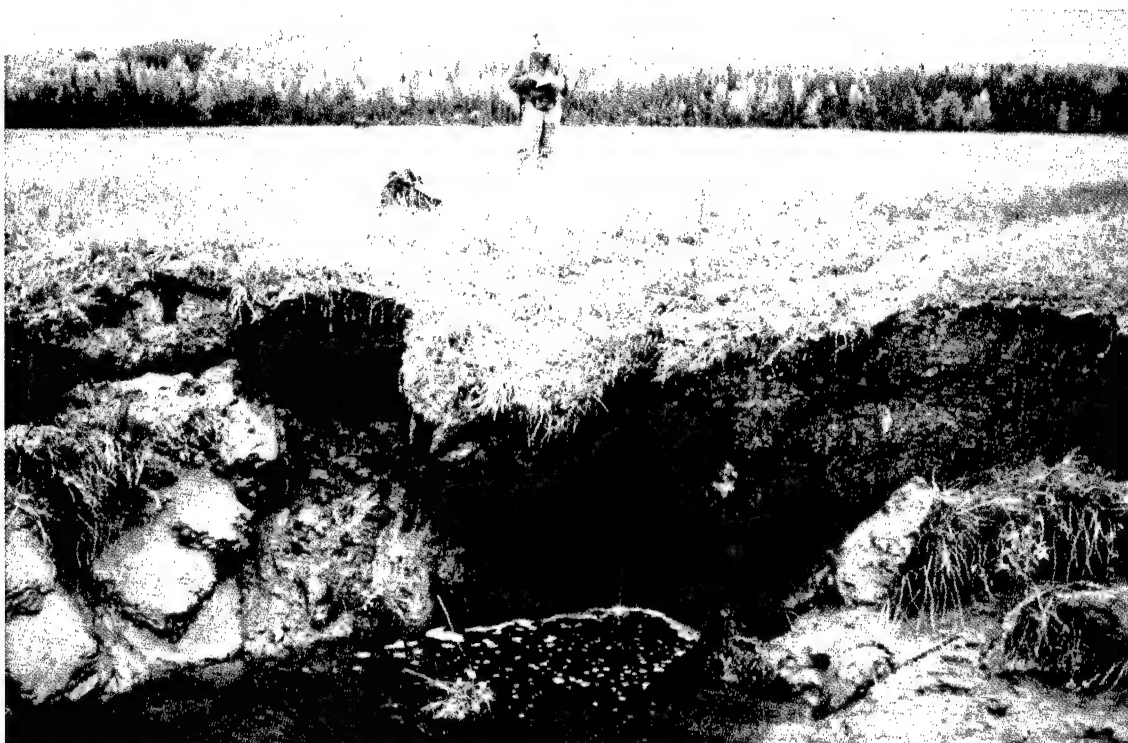
Figure 30. Thick laminated peat layer at Coastal 6 forms the threshold to channel downcutting and headward recession.

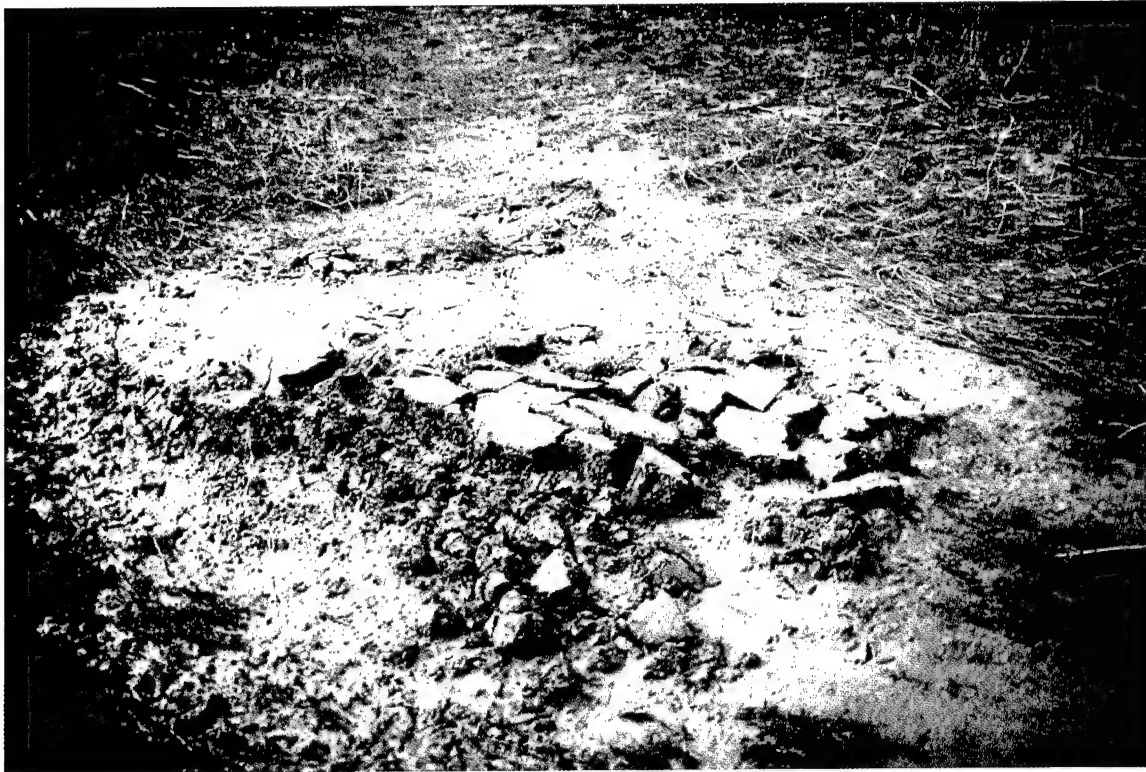
a. Sediment layer frozen onto an ice block transported during the November 1994 flooding tides.

Figure 36. Ice rafting at ERF.

b. Ice-rafted sediment deposited at the head of Mortar Gully.
